Case Studies of Lightning Related Injuries and Property Damage in Zambia

Abstract— This is the first investigation and analysis of lightning related incidents in Zambia. Two case studies on both human injuries and equipment damage at five sites are reported. Lightning injuries were mostly attributed to the lack of proper structural protection systems, although lack of awareness among the public may also contribute to the situation. Many injury mechanisms, including unsuccessful upward streamers, may cause injuries. Design of lightning protection schemes should take social structures and affordability by the affected public into account. Losses in the power sector are excessively high in the region and seriously affect the operation of both business and domestic life. Replacement cost incurred by the power companies can be prohibitive. Lightning density and pattern in the localized areas, grounding systems of the installations, and specification and installation techniques of lightning arresters should be revisited in giving proper solutions to transformer and power line failures.

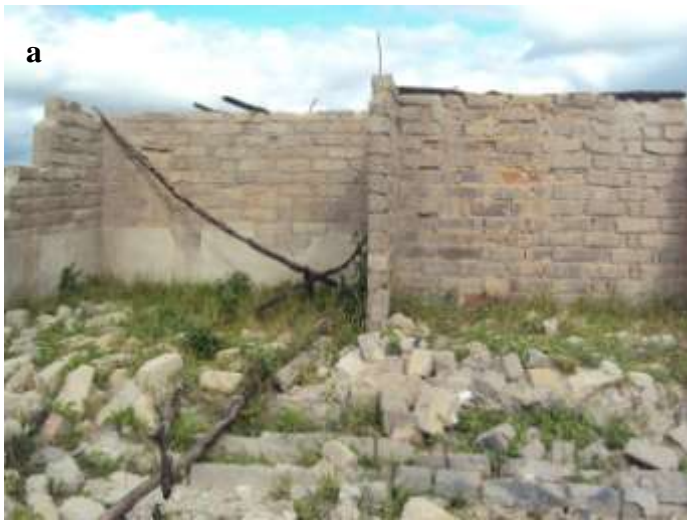
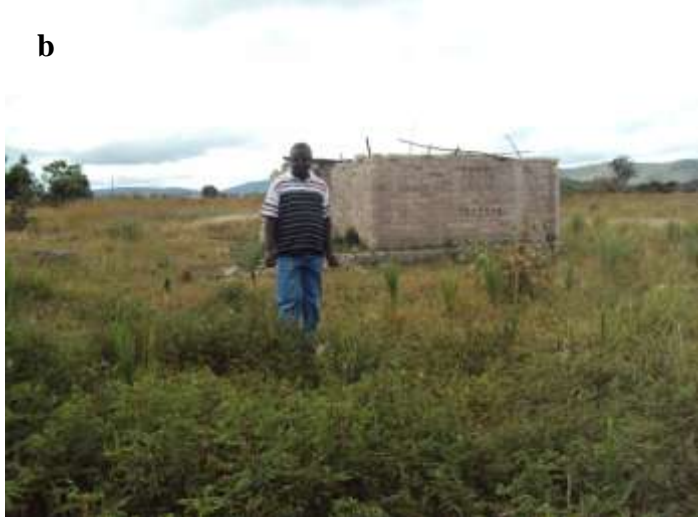
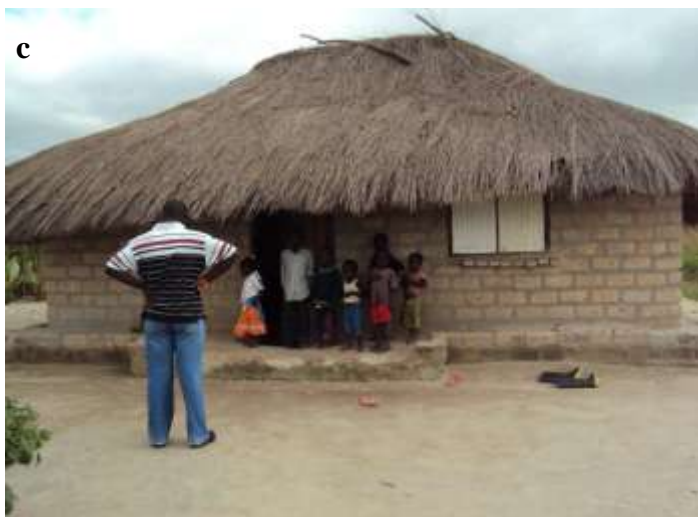
- a. Site1: Reports by many Zambian newspapers as well as the internet related that a house in Kasansama village in Mkushi had been struck by lightning, killing five members of the same family. Fig.-2 shows the affected house reported in case under consideration.

According to the neighbors, it appeared that the father and an 18 month old baby were in the bedroom while the mother and three children were in the sitting room when the lightning struck. It seems that lightning struck the roof near the bedroom which immediately caught fire. The father and the baby were severely burned while the mother and two of the three children, a girl and a boy, were found dead in the kitchen. All three bodies looked grayish in color and white froth appeared to be coming out of the mother's mouth. The third child, a little boy estimated to be around three years old, was found alive standing in the corner of the kitchen. According to eye witnesses, he looked quite oblivious to what was going on around him

Figure 2 a. Remnants of the affected house after it was burnt by fire caused by lightning
 b. Police officers shows the place where they found the bodies after they were pulled out by Mr Siame
 c The affected house was very similar to this before being burnt by fire

The incident reported in Case 2/Site 1 is most likely due to a direct strike to the unprotected thatched roofed house. However, as per the details given by the eye witness it seems that the victims succumbed to their lightning injuries rather than the consequent house fire. A probable explanation for the cause of death is side flashing from the roof or walls after the structure is attached with the stepped leader. The three-year old child may have been spared due to his lower elevation which reduced the possibility of side flashing from the roof.

Due to the low per capita income of the public any expensive protection system will not be practically viable in most parts of Zambia. Safety and protection schemes need to be designed to be affordable, easily installed, easily maintained, and effective in lightning dense areas. Several less expensive lightning protection schemes for the low-income societies in Asia and Africa have been proposed [5].

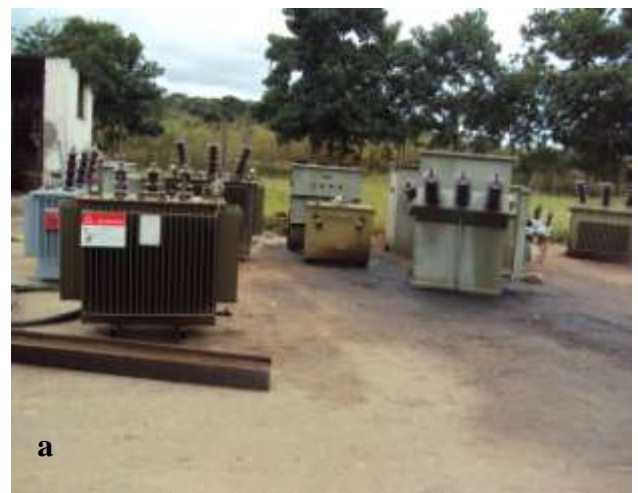
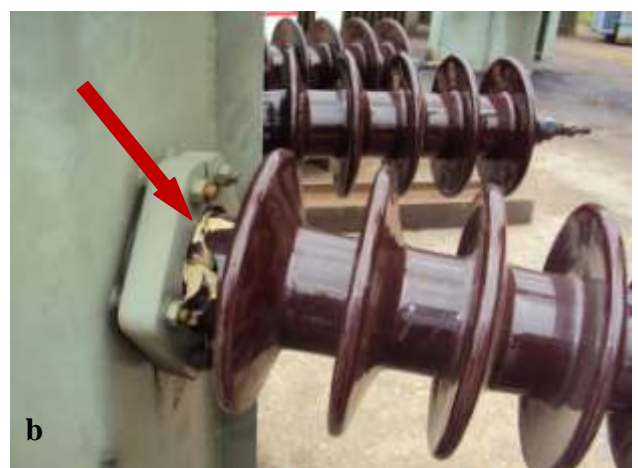
Since transformers are usually imported to Zambia from Europe it may take up to six months to replace a damaged transformer. The losses are unbearable with companies in the region making regular complaints regarding loss of business due to power downtime. At the domestic level a major problem is loss of perishable food in cold storage. Fig.3 show transformers which were affected within a period of two months in the area and the parts affected.

As per the ZESCO officers, transformers are damaged despite good grounding systems and also in the presence of lightning arresters. Lightning arresters are also damaged in most cases.

Figure 3 a. Damaged transformers in the ZESCO yard in Mkushi
 b. Damaged part of the transformer

We basically focused our attention on two important observations in these cases. Transformers and poles are frequently damaged despite seeming to have good grounding systems and surge arresters.

It will be of interest to find how "good" these grounding systems are. Interviews done with root level engineers in many African countries revealed that the acceptability of the grounding system (both design and implementation) is based on individual perceptions rather than scientific information or guidelines given in standards. The TOE expects to conduct further investigations in this regard.
