School Survey
ATOROMA PRIMARY SCHOOL – KATAKWI DISTRICT (Northeastern Uganda)

SURVEY TYPE: Primary Survey

Dates of survey: 18th Sept 2023

Name of school: Atoroma Primary School

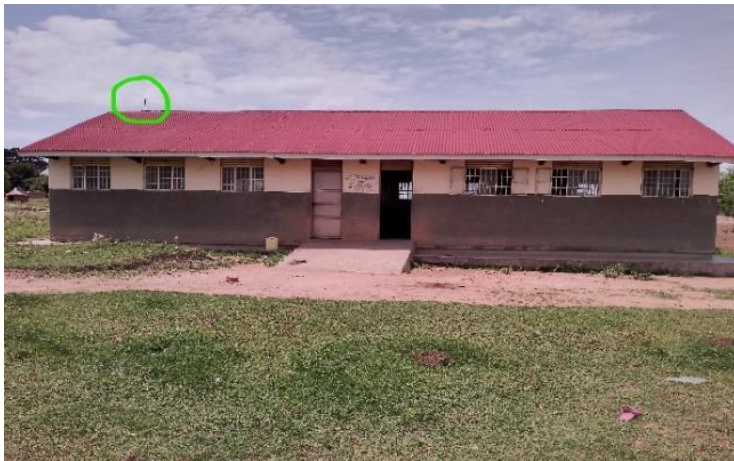
8. Most Trees around the school are more than 10 meters high
9. There are electricity line poles around the school.
10. Building X was struck by lightning yet it was installed by Government. It has one air termination as you can see in the picture below.

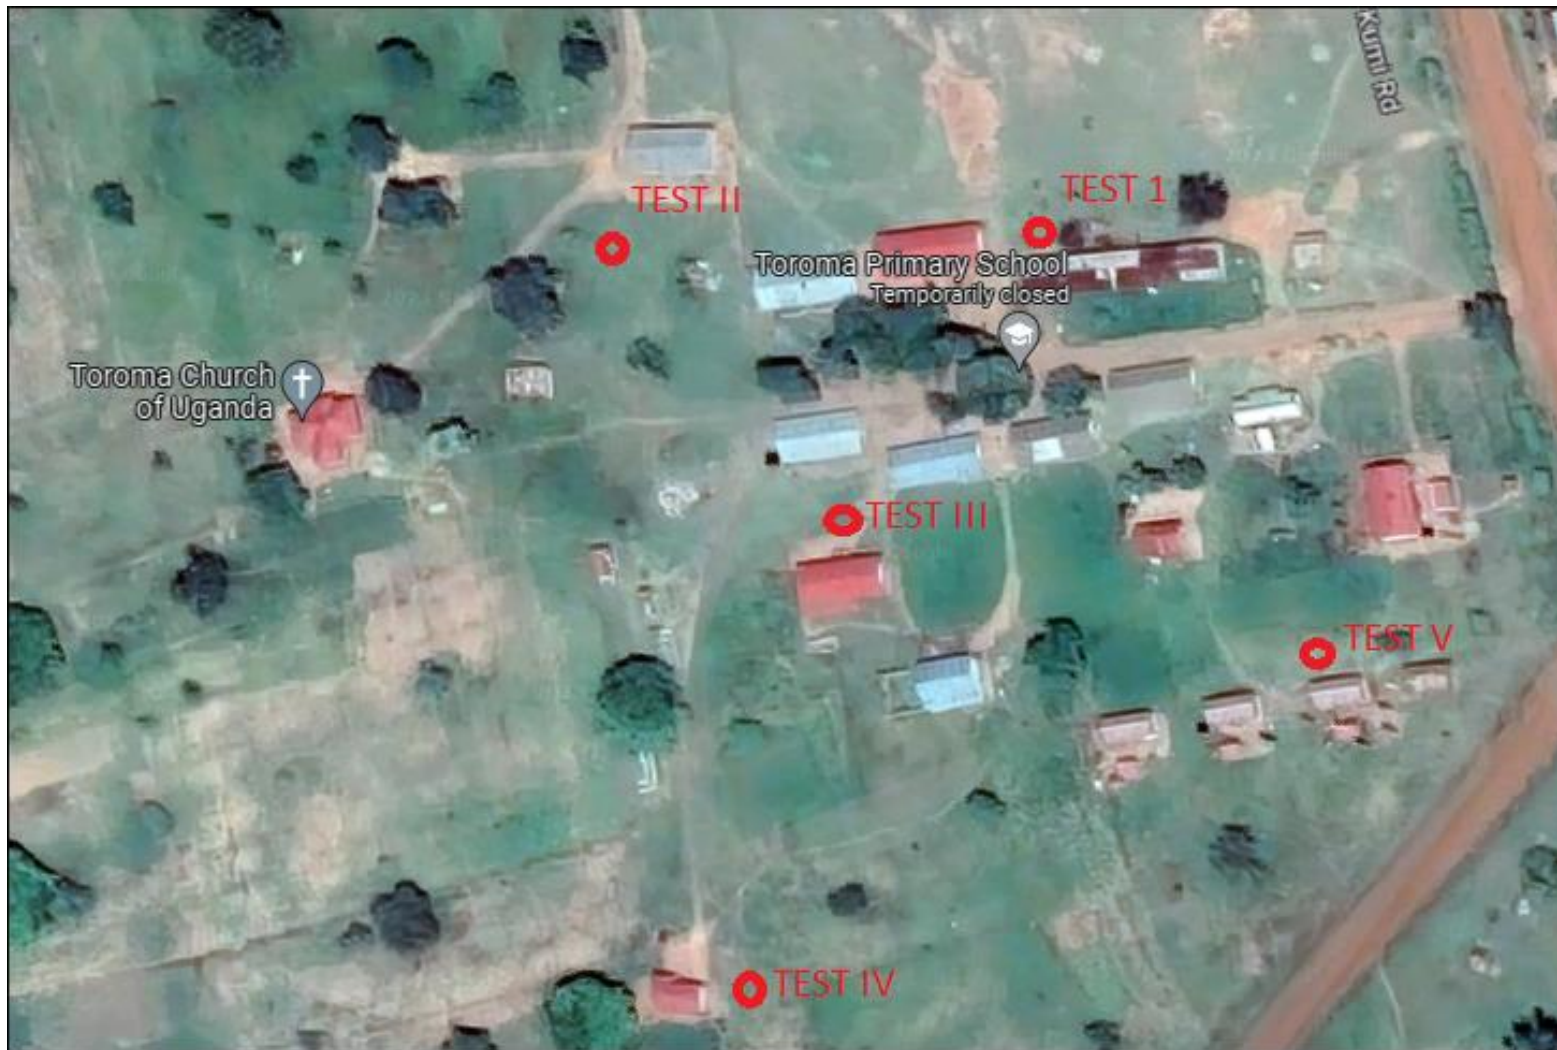
Sketch map showing. Soil tests shown in site photo.

Take readings at several locations around the area, preferably at each building, and note these on the sketch or describe the location; see layout map sketch page 3 and photo page 4

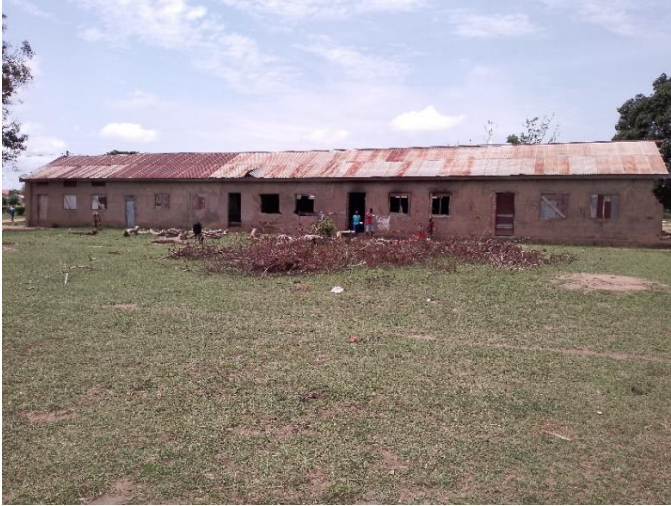
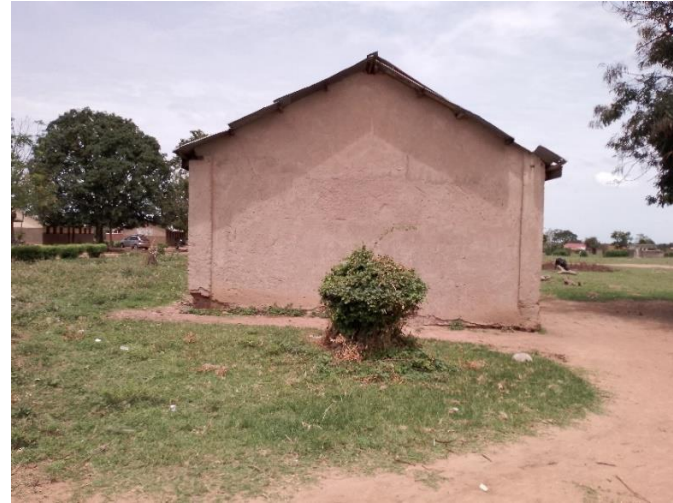
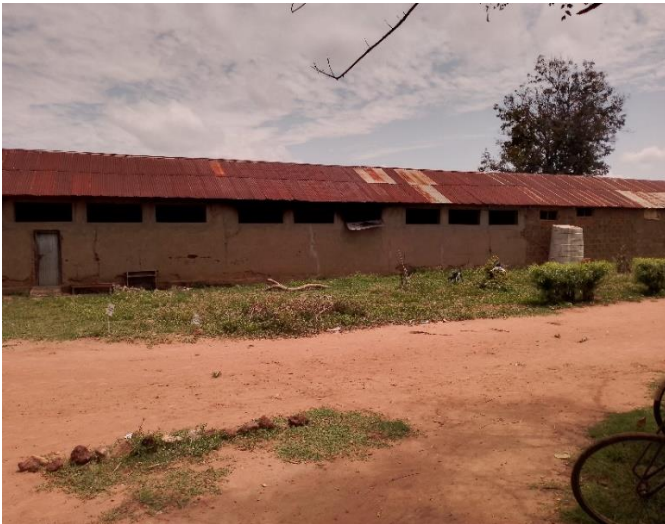
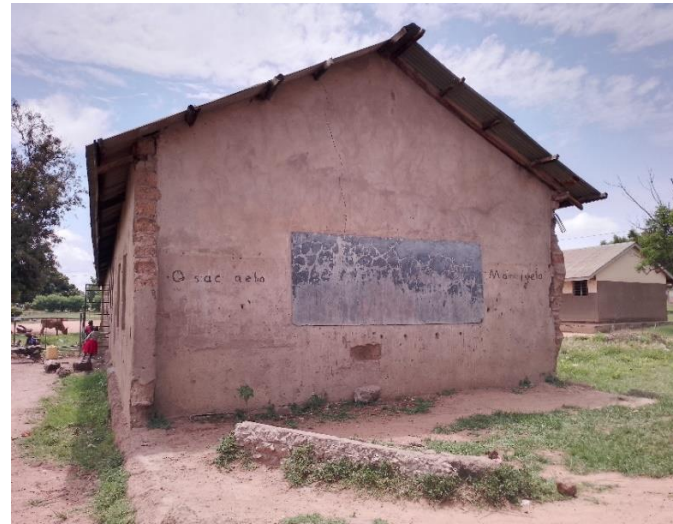
BUILDING B – Classroom block w Kitchen

B. Classroom block./ Kitchen	Sheet iron, extensively rusted	Concrete chipped and broken	Mud but burnt bricks with plaster – not in good condition	no veranda
C, classroom block/ Administration office	Iron sheet in good condition	Concrete floor in good condition	Mud but burnt bricks with plaster good condition	1M wide veranda in front
D, classroom block	Iron sheet in good condition	Concrete floor in good condition	Mud but burnt bricks with plaster good condition	1M wide veranda in front
E, Church	Iron sheet in good condition	Concrete floor in good condition	Mud but burnt bricks with plaster good condition	1M wide veranda in front
F, Reverend house	Iron sheet in good condition	Concrete floor in good condition	Mud but burnt bricks with plaster good condition	1M wide veranda in front
G, classroom block	Iron sheet in good condition	Concrete floor in good condition	Mud but burnt bricks with plaster good condition	1M wide veranda in front

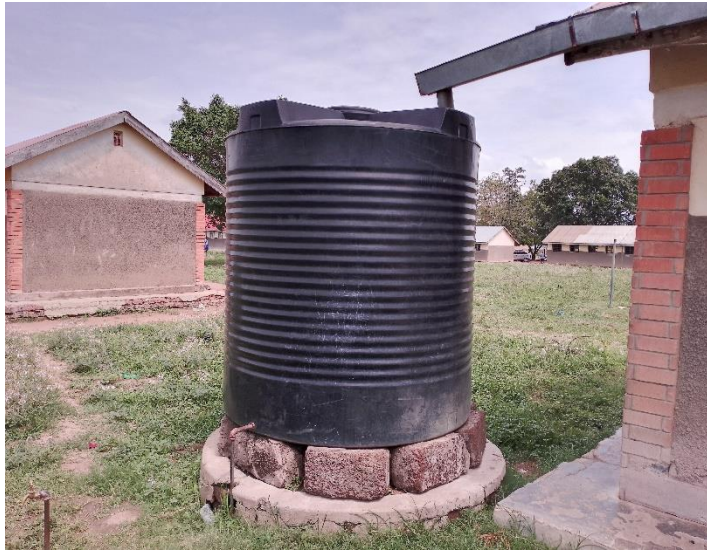
water tank on the western side of building R
